Public Comment on the Environmental Assessment (EA) by
The Federal Energy Regulatory Commission (FERC) of
The Texas Eastern Appalachia to Market (TEAM 2014) Project
in FERC Docket CP13-84-000

James E. Rosenberg
555 Davidson Road
Grindstone, PA 15442
Fayette County
(724) 785-9398
October 16, 2013

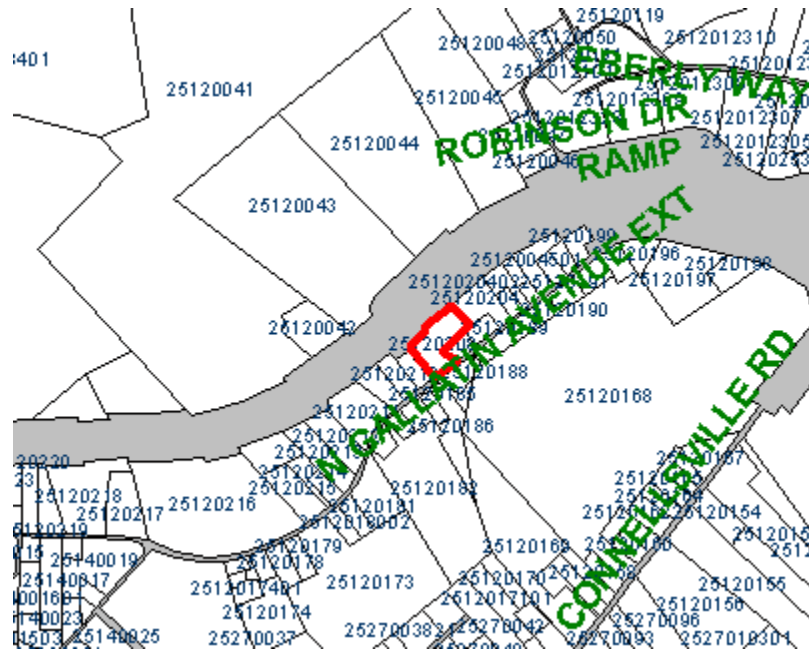
Attachment A
Property Map Showing the Property of Thomas Koziel in Relation to Uniontown
Compressor Station

The Texas Eastern property for Uniontown Compressor Station is shown as parcel # 25120168. Mr. Koziel's property is outlined in red, parcel number 25120208.

(This matter is still in litigation.) Attachment A shows a Fayette County property map giving the relationship of Mr. Koziel's parcel to the parcel containing the Uniontown Compressor Station. Surely the potential for noise to cause adverse health effects at Uniontown Compressor Station will only get worse as the power is upgraded, unless specific mitigation measures are taken. Assessment of noise levels that does not take into account the possibility of blowdown or malfunction is inadequate.
